Bloody Point Park – April 19, 2021

Create a public park with a rehabilitated Railroad Depot/Tolltaker residence.

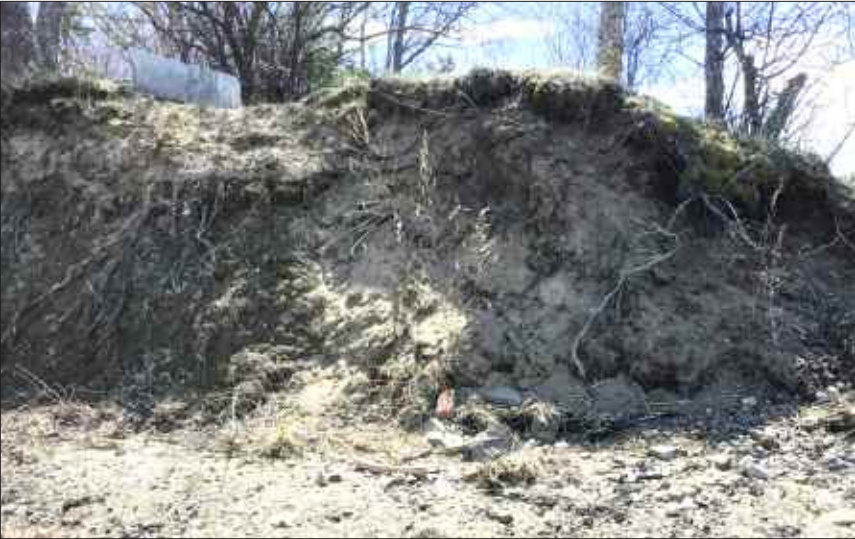
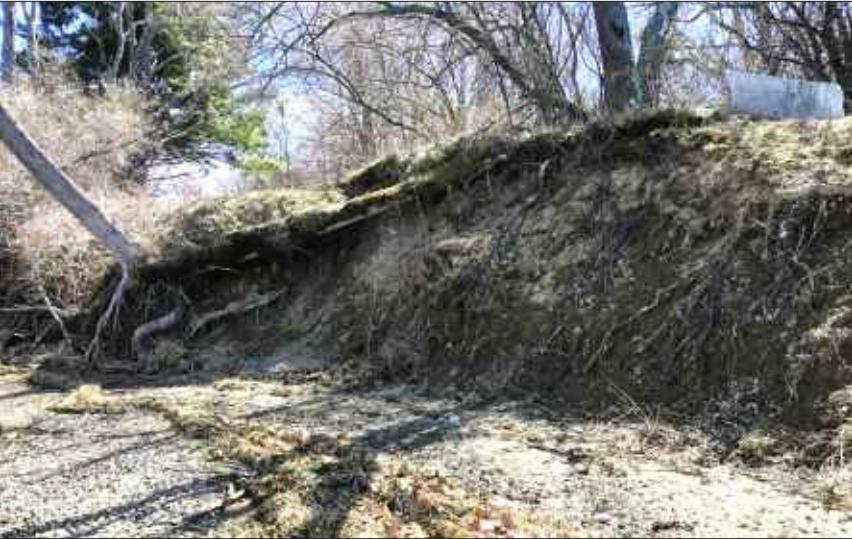
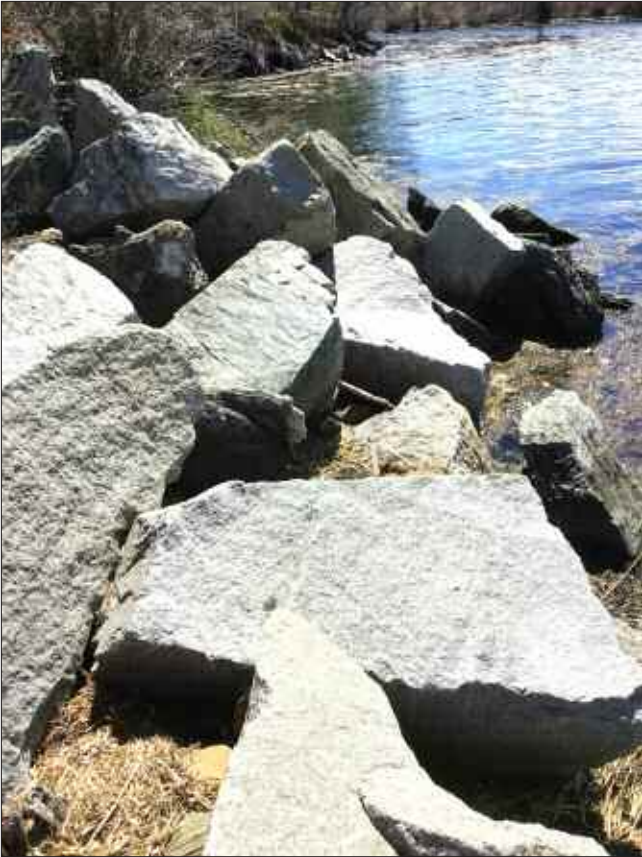
The river side of the point facing Eliot has the most vulnerable erosion areas.

The end of the point facing Hilton Park already has boulders that may be sufficient.

The turnpike side of the point also has some erosion issues but many small boulders already line parts of the shoreline.

Shoreline stabilization is likely to be the most expensive piece of the land rehabilitation plan

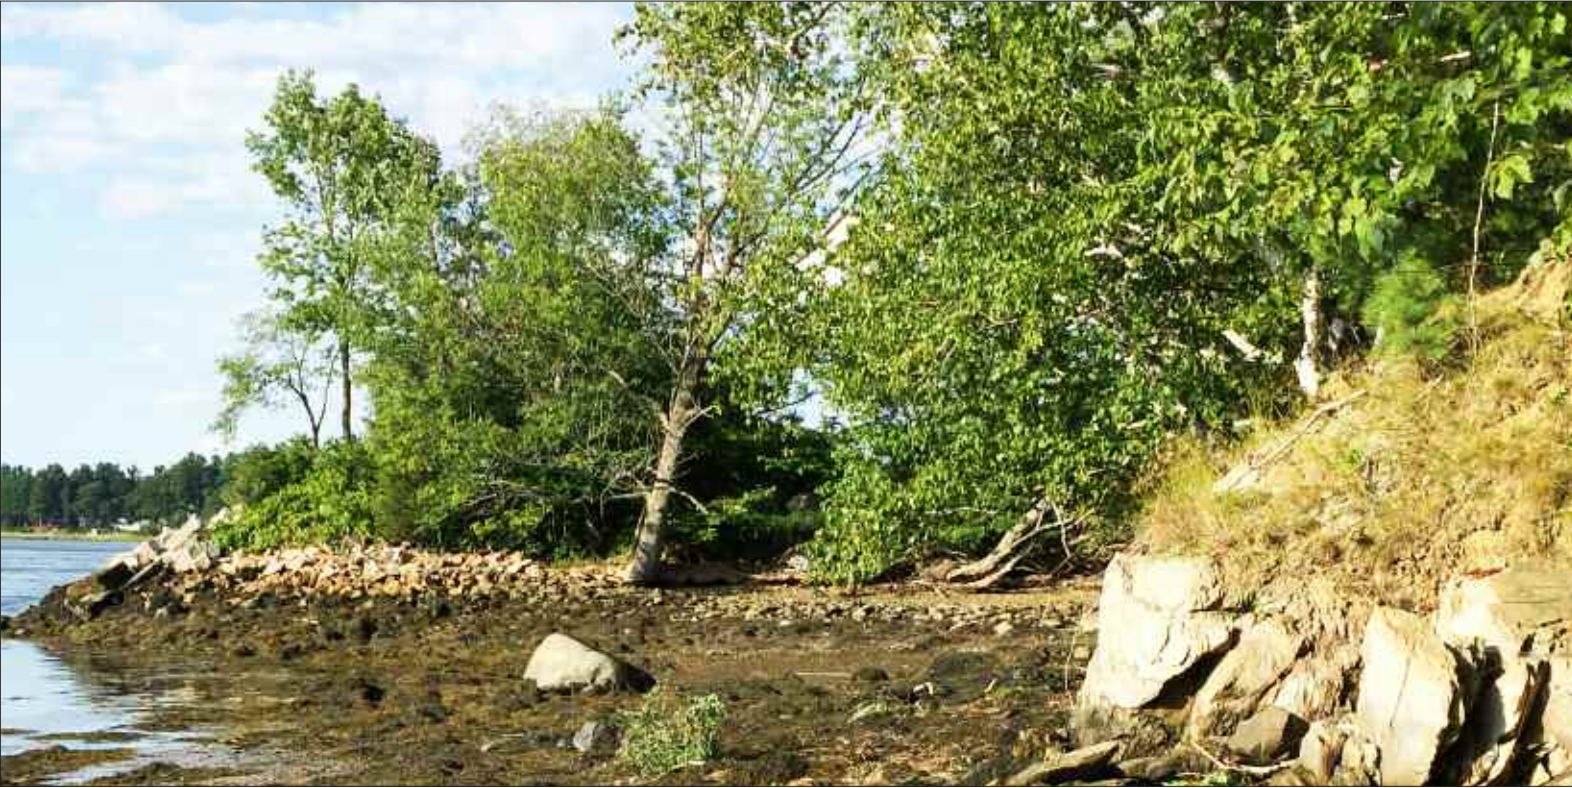
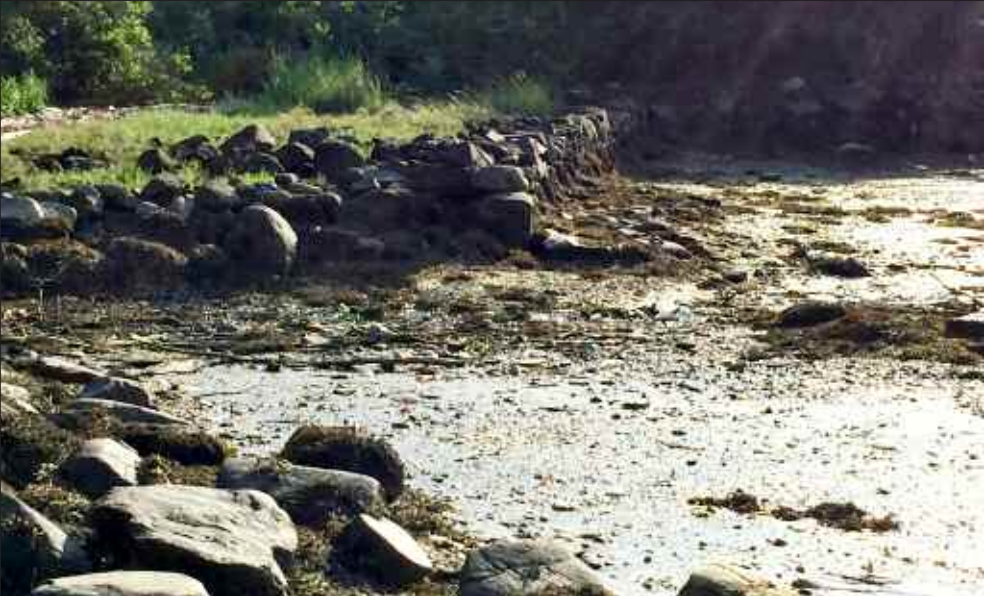
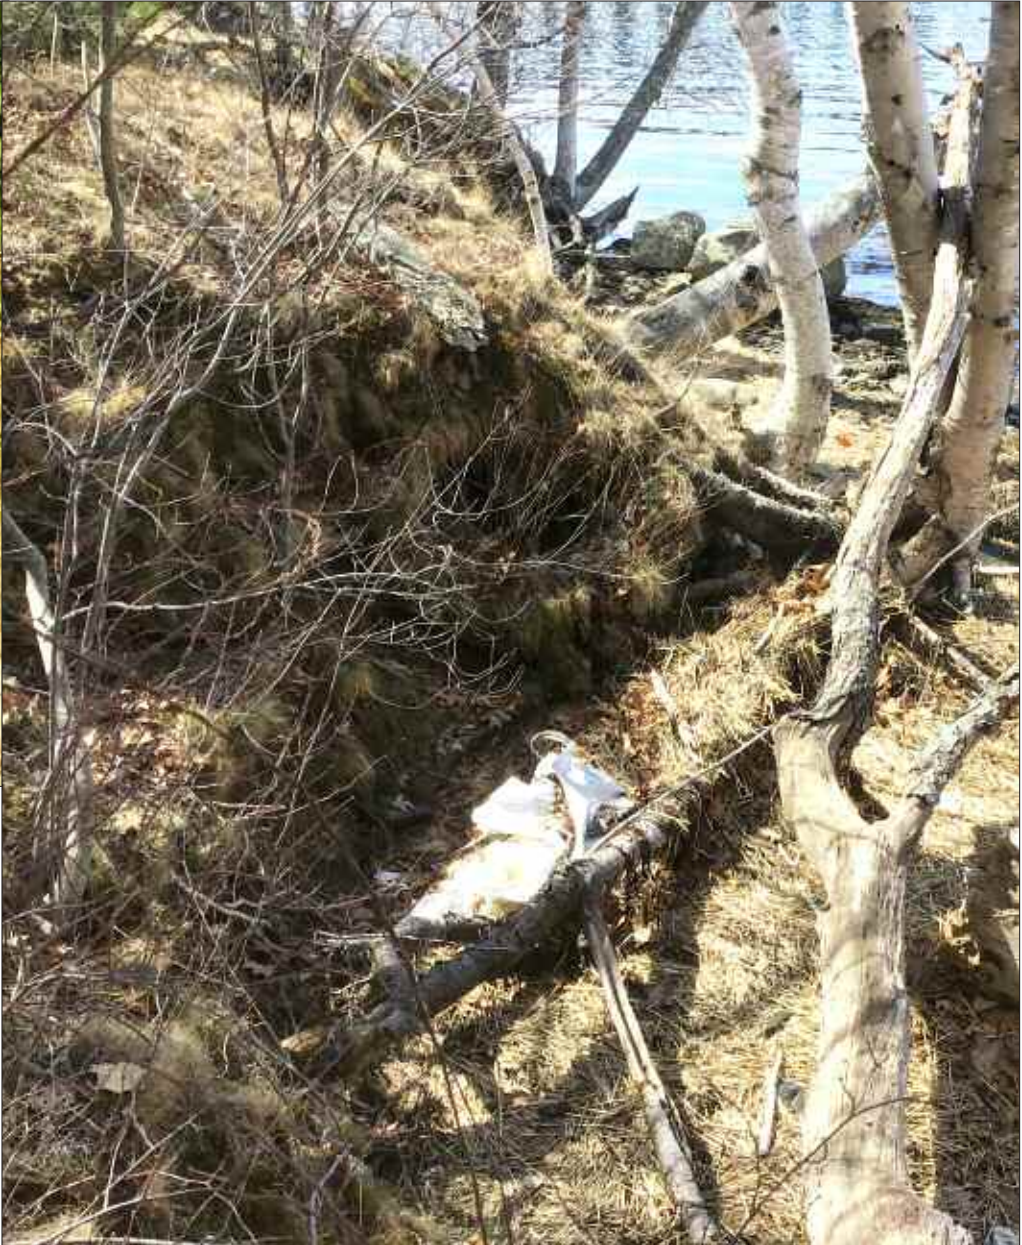
Shoreline erosion is a concern - turnpike side of point

The turnpike side of the point also has some erosion issues (right photo).

Many small boulders already line parts of the shoreline (photo above and to the left).

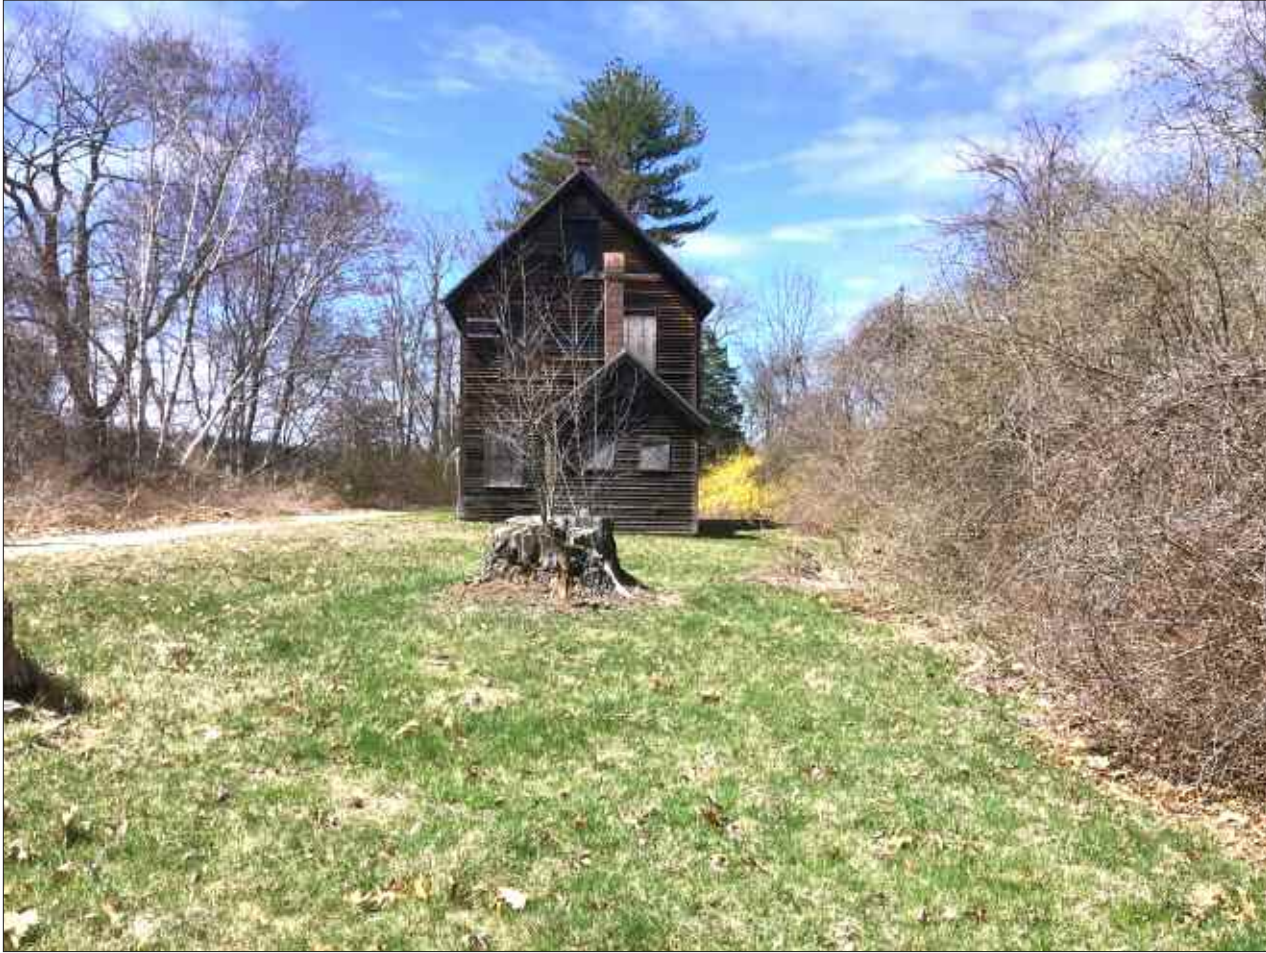
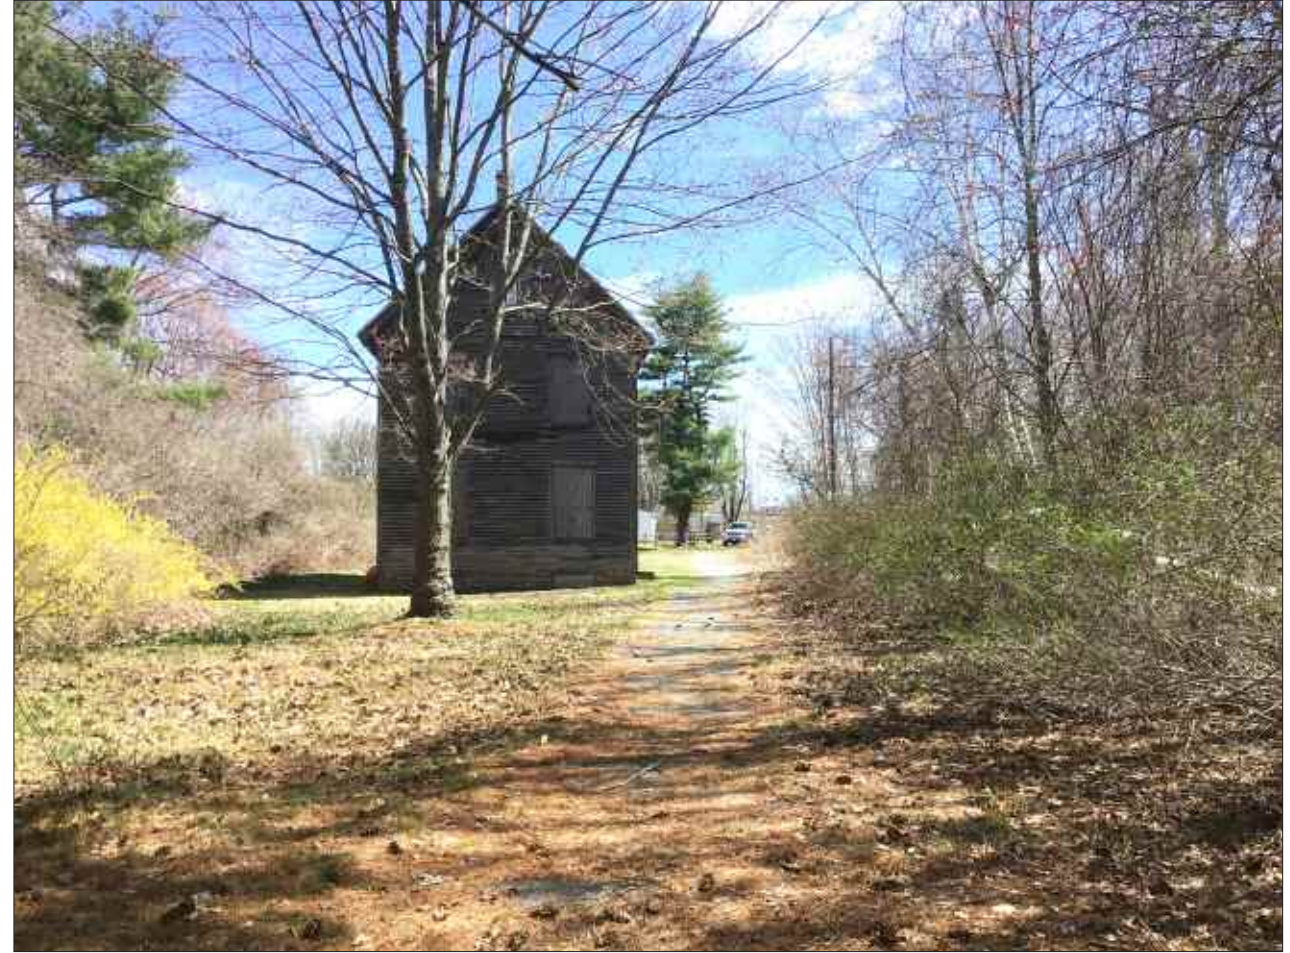
The broken asphalt driveway should be removed so the grounds can be graded away from the front of the building so water does not flow into the cellar.

Note the different ground elevation on the driveway side of the building. Rain and snow can pool by one side of the foundation and cause a wet basement.

Replace house gutters to direct water away from foundation.

Install appropriate drainage around the building perimeter.

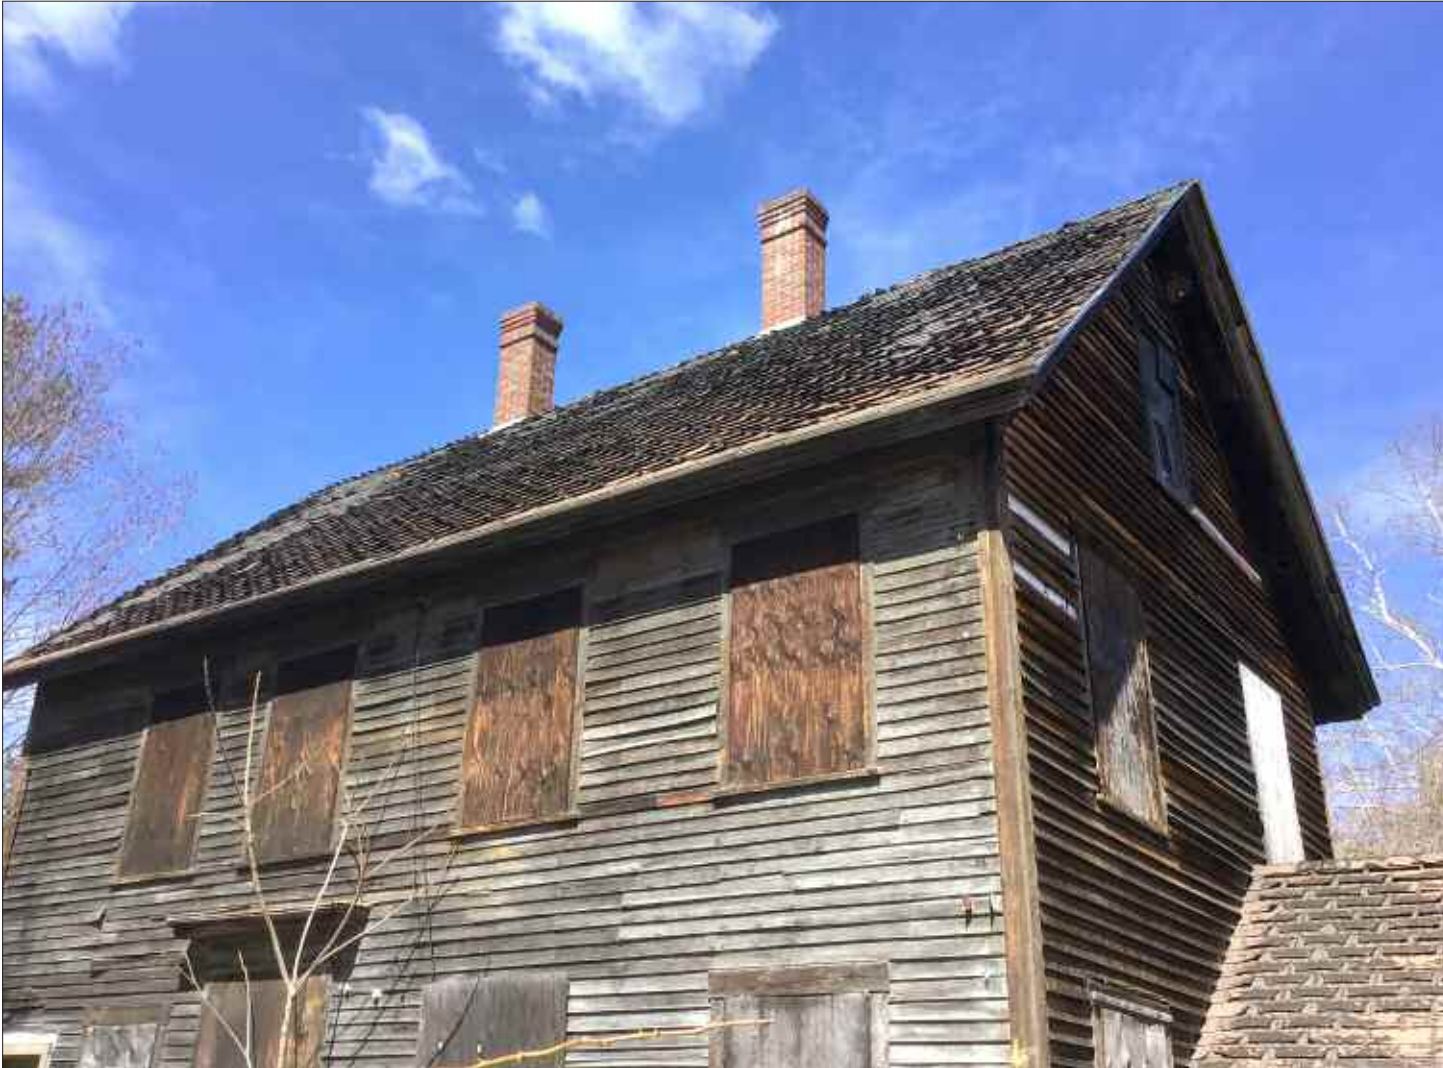
House and shed roofs need to be reshingled.

Roof sheathing needs to be checked for water damage and replaced as needed.

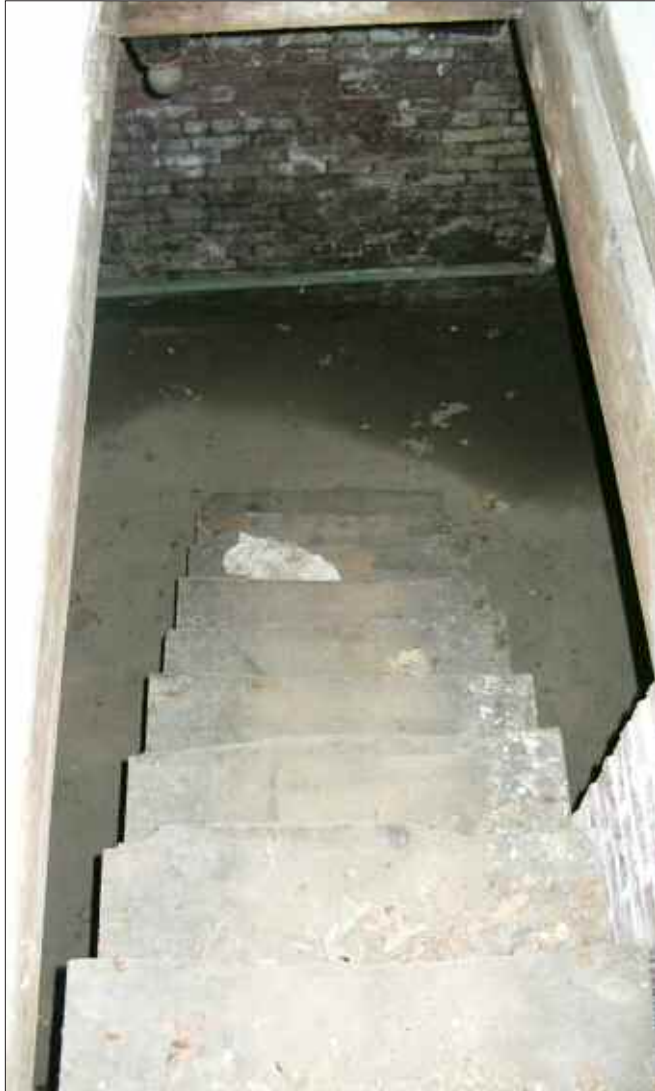
Wet cellar means water is coming through the front foundation.

Need to regrade the lawns and install drainage around the perimeter of the building so water drains away from the foundation.

Repoint the brick foundation.

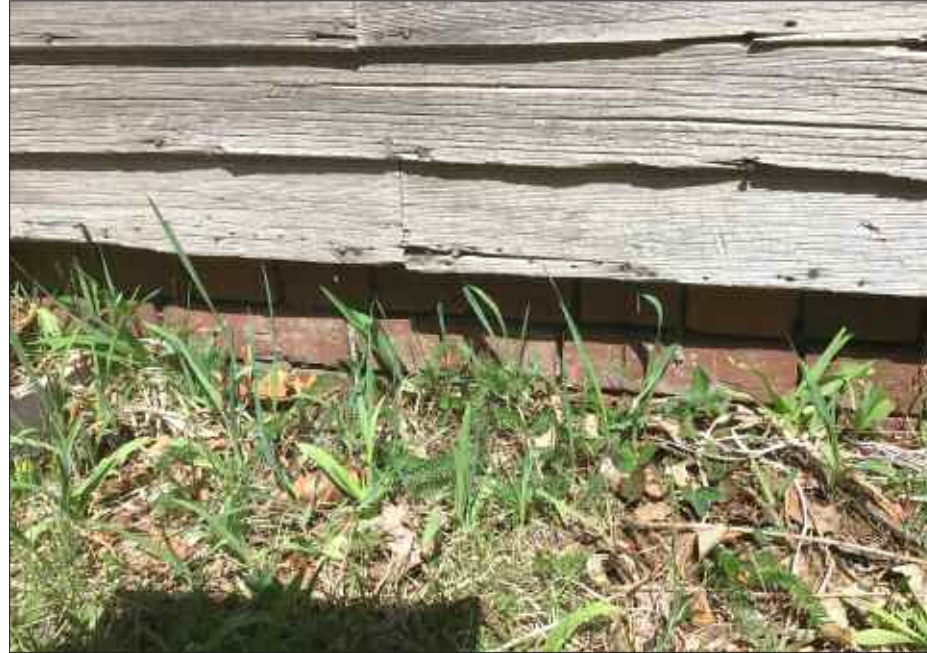
Bricks need to be repointed to keep out water (above).
Front sill is rotten in places (below).

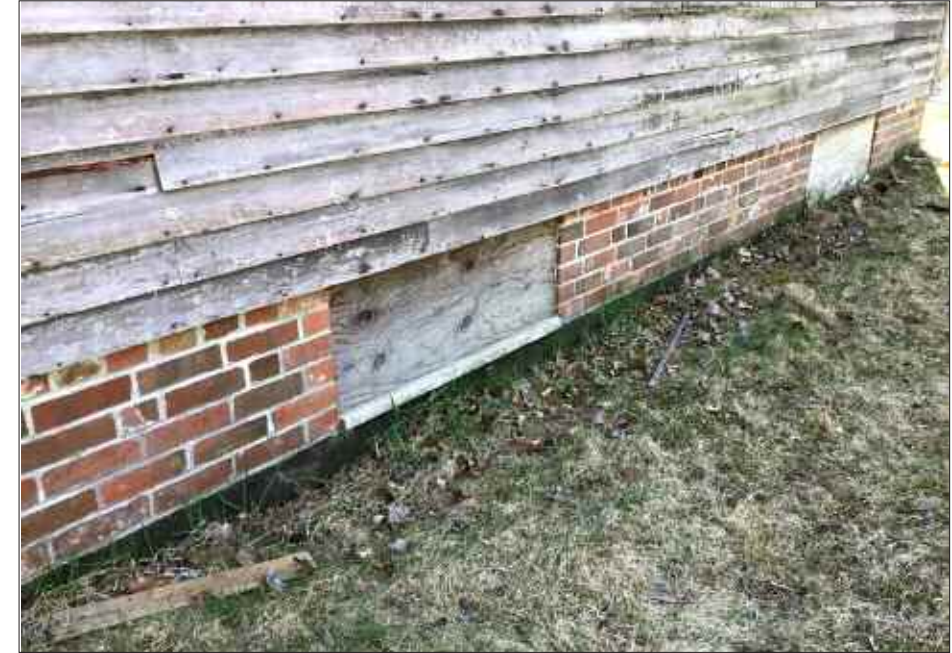
The back foundation looks better (above).
Grading and drainage is needed.

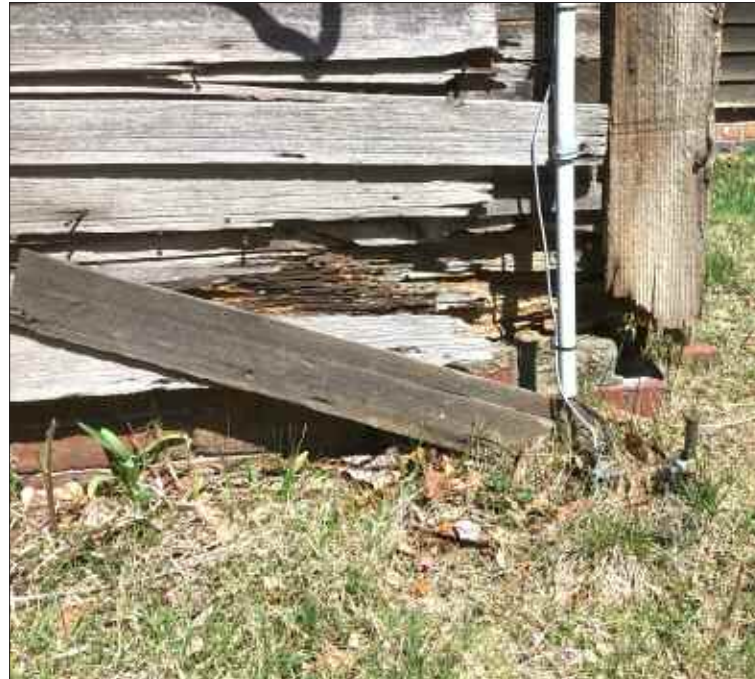
The inside sills and brick foundation in the shed (right) looked new in 2009

A floor needs to be installed in the shed to create a crawl space below for electric, plumbing, etc.

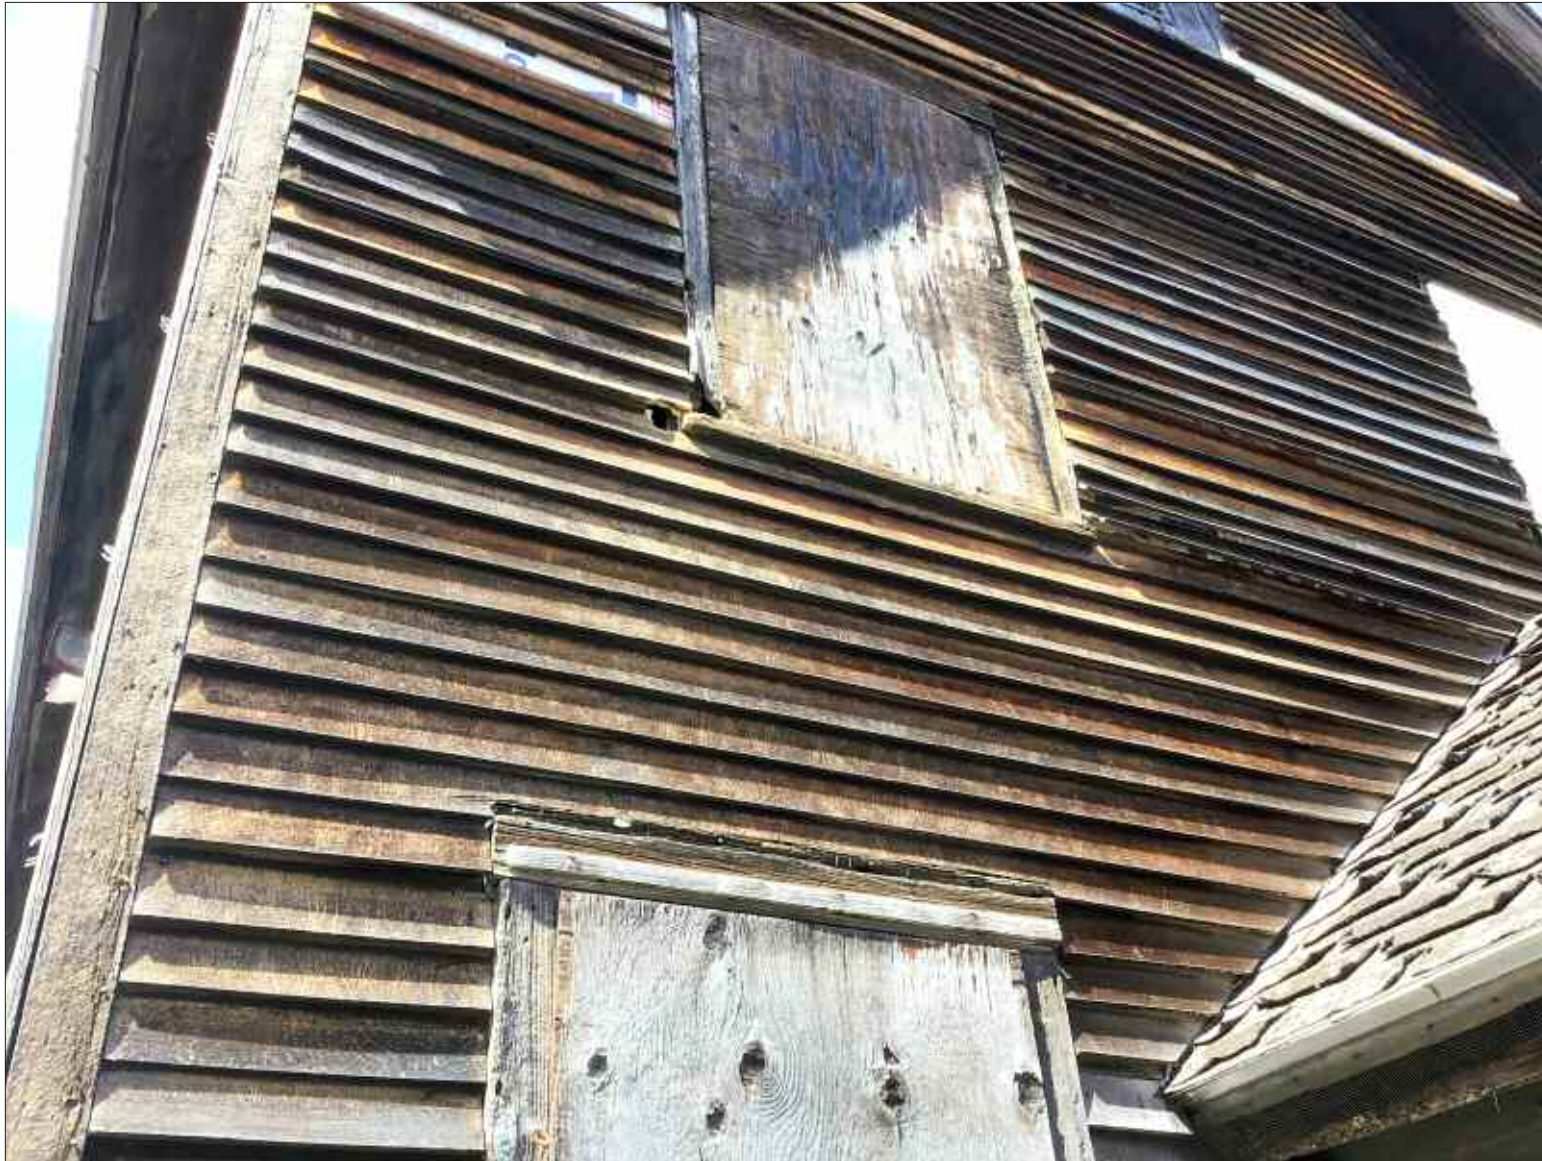
Outside clapboards need to be replaced. Sheathing underneath checked and replaced as needed.

Animal and insect issues need to be addressed.

All trim needs to be replaced with Azek trim.

Windows and some doors need to be replaced, and storm windows (heat loss and noise) and gutters installed.

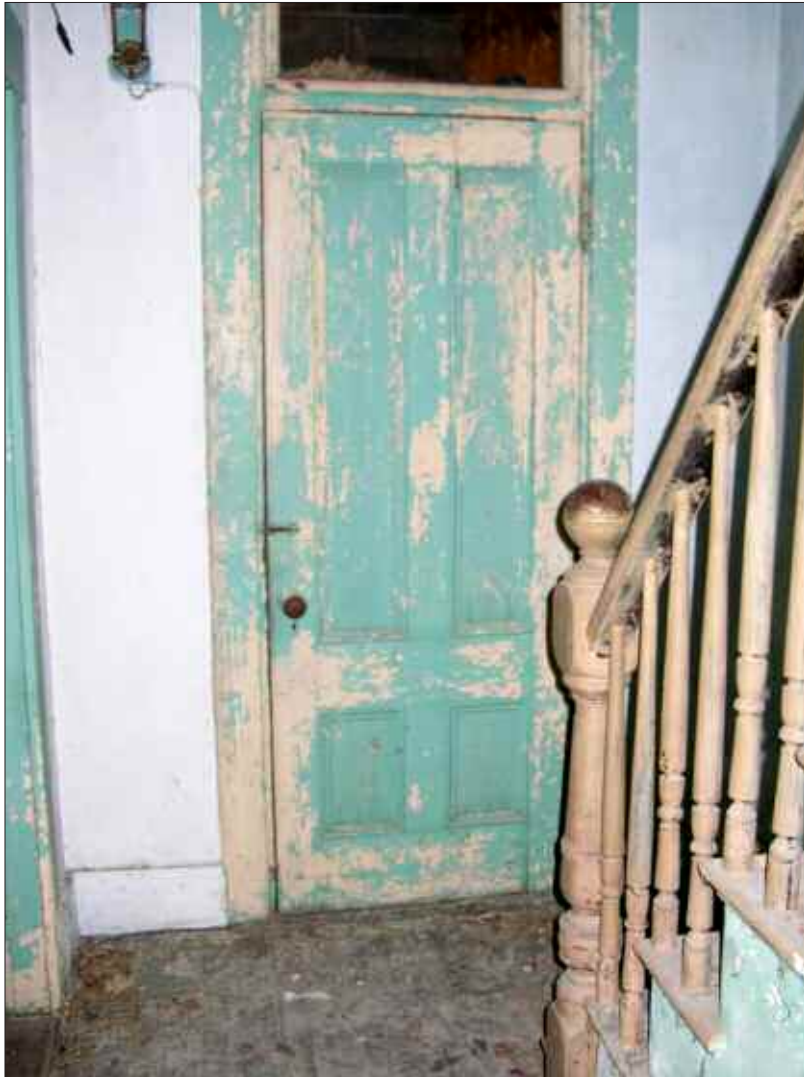
In 2009, the floors looked to be wood and in good shape. They could be sanded and refinished.

The front door looks like it could be reused.

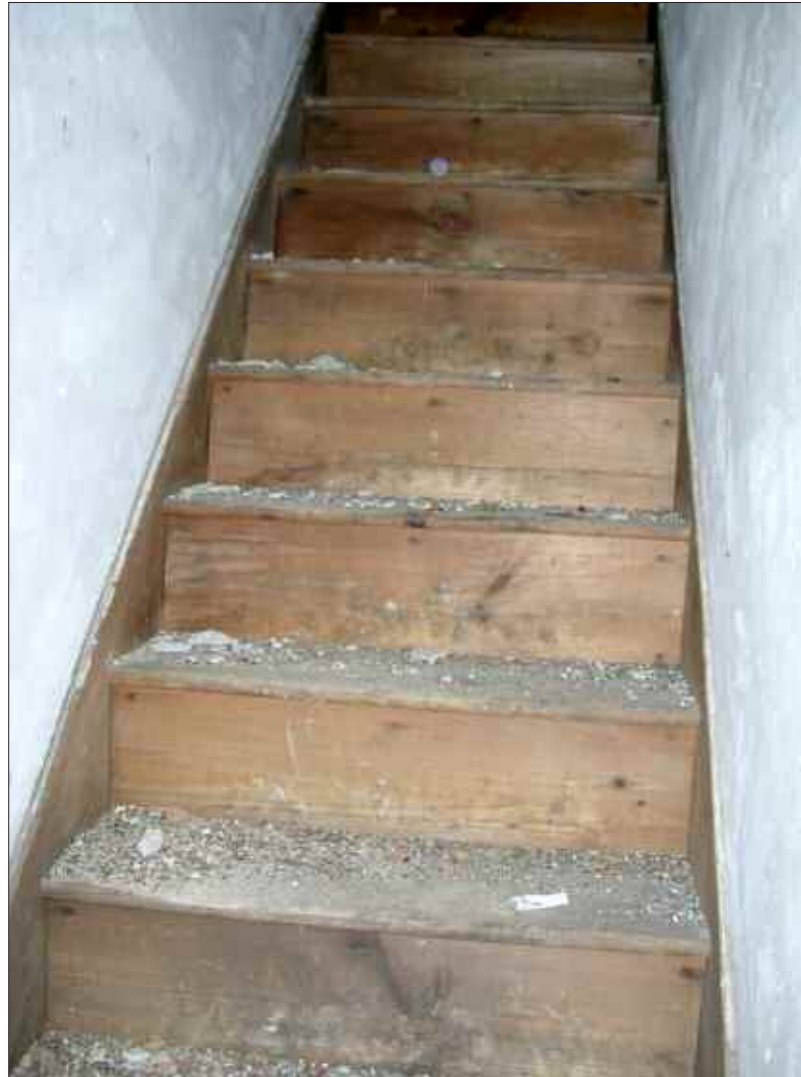
The bannisters look in good shape. Their height needs to be checked for code, an iron rail could be installed at code level if needed.

Although not to code, the building is historic and the 3 stairs can likely be refinished and used as is. Note the good state of repair of the plaster walls.

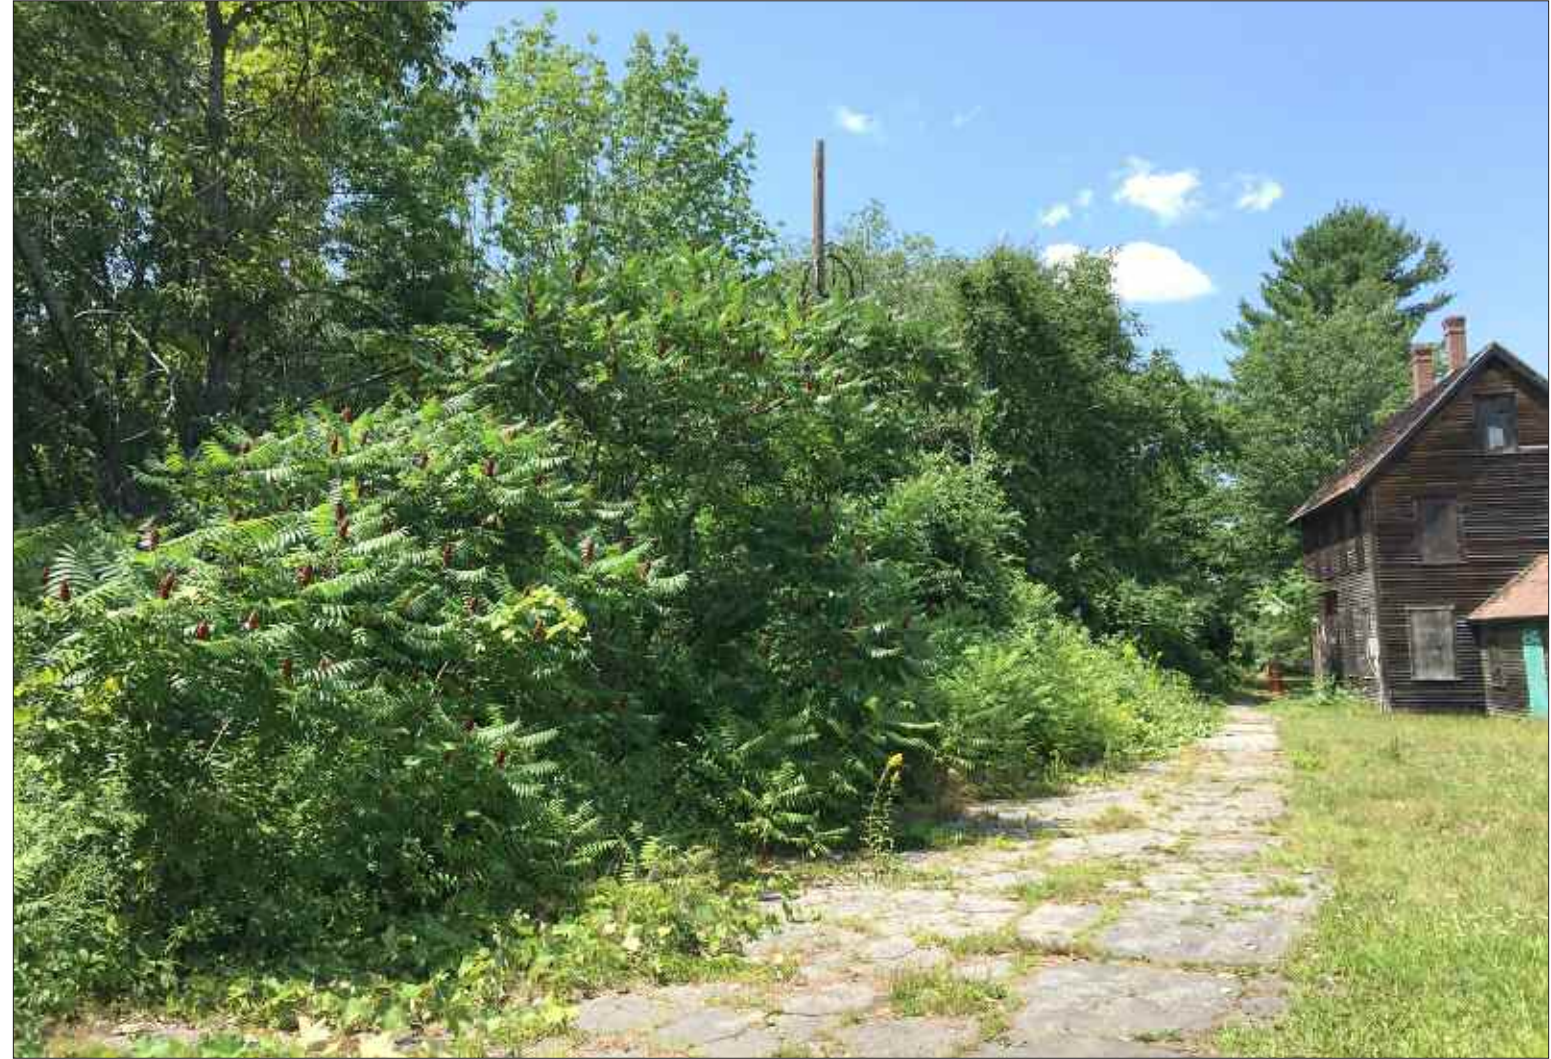
The driveway is in poor shape and could be removed. Removing impervious surfaces will help with shoreline buffer discussions.

An existing electric pole is seen above.

The lot is grandfathered, but electric, water, and communications lines could be installed underground.
