Bloody Point Park – April 19, 2021

Create a public park with a rehabilitated Railroad Depot/Tolltaker residence.

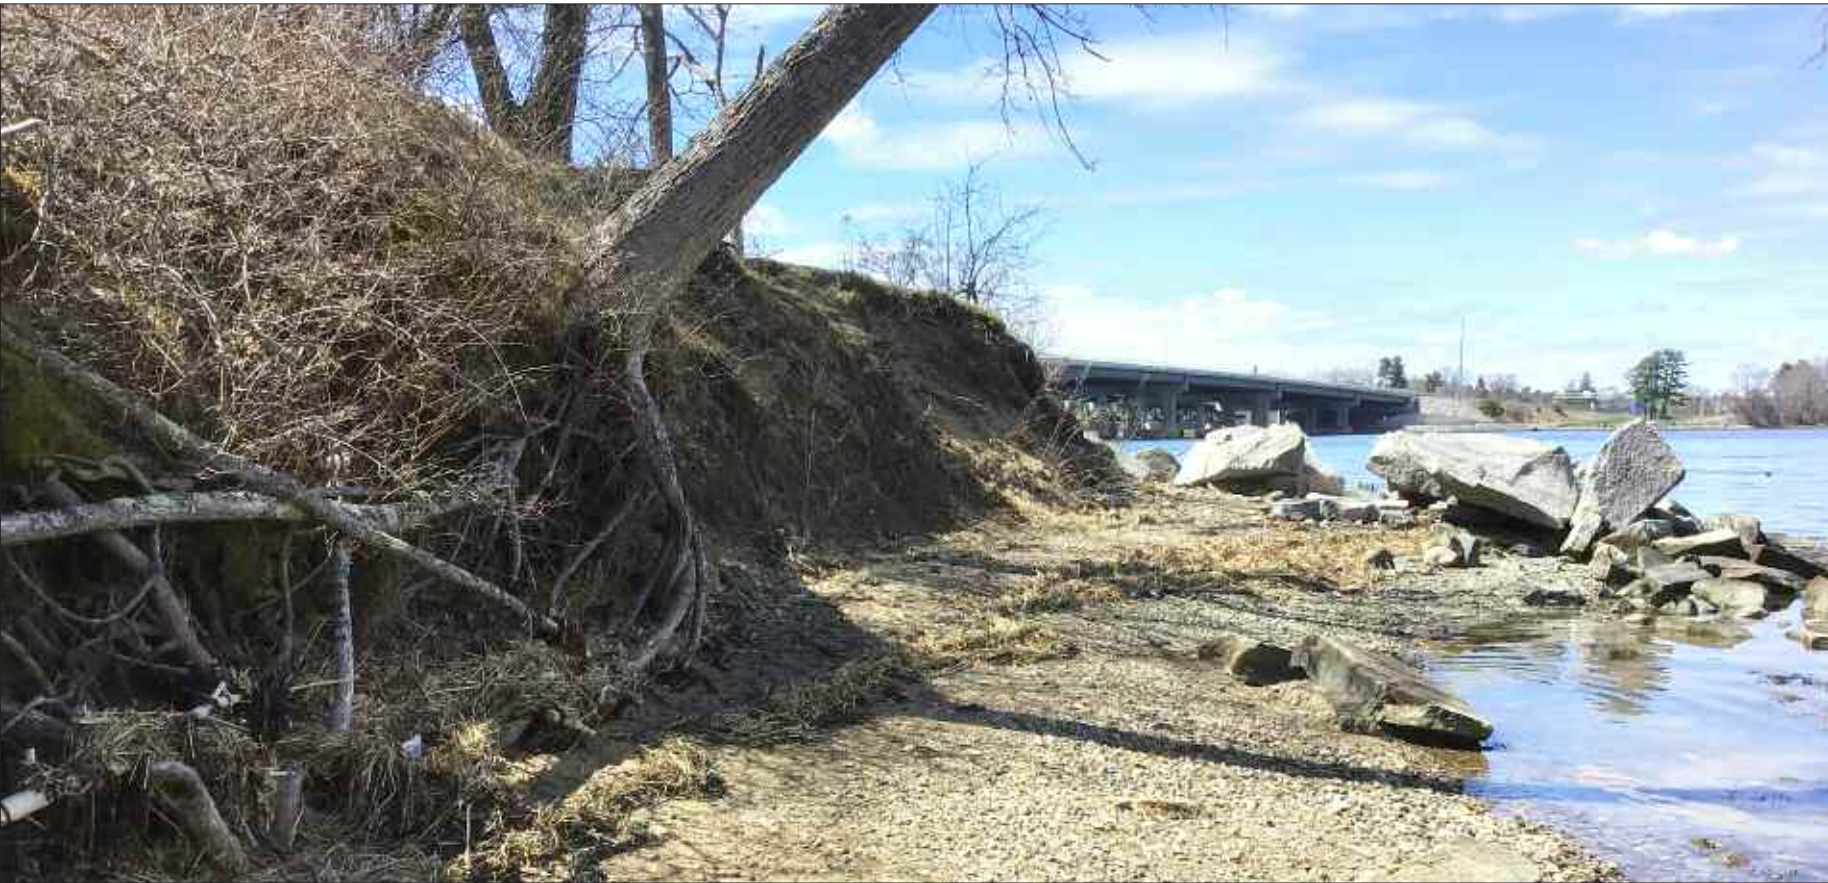
Shoreline erosion is a concern

Shoreline stabilization is likely to be the most expensive piece of the land rehabilitation plan

The river side of the point facing Eliot has the most vulnerable erosion areas.

The end of the point facing Hilton Park already has boulders that may be sufficient.

The turnpike side of the point also has some erosion issues but many small boulders already line parts of the shoreline.

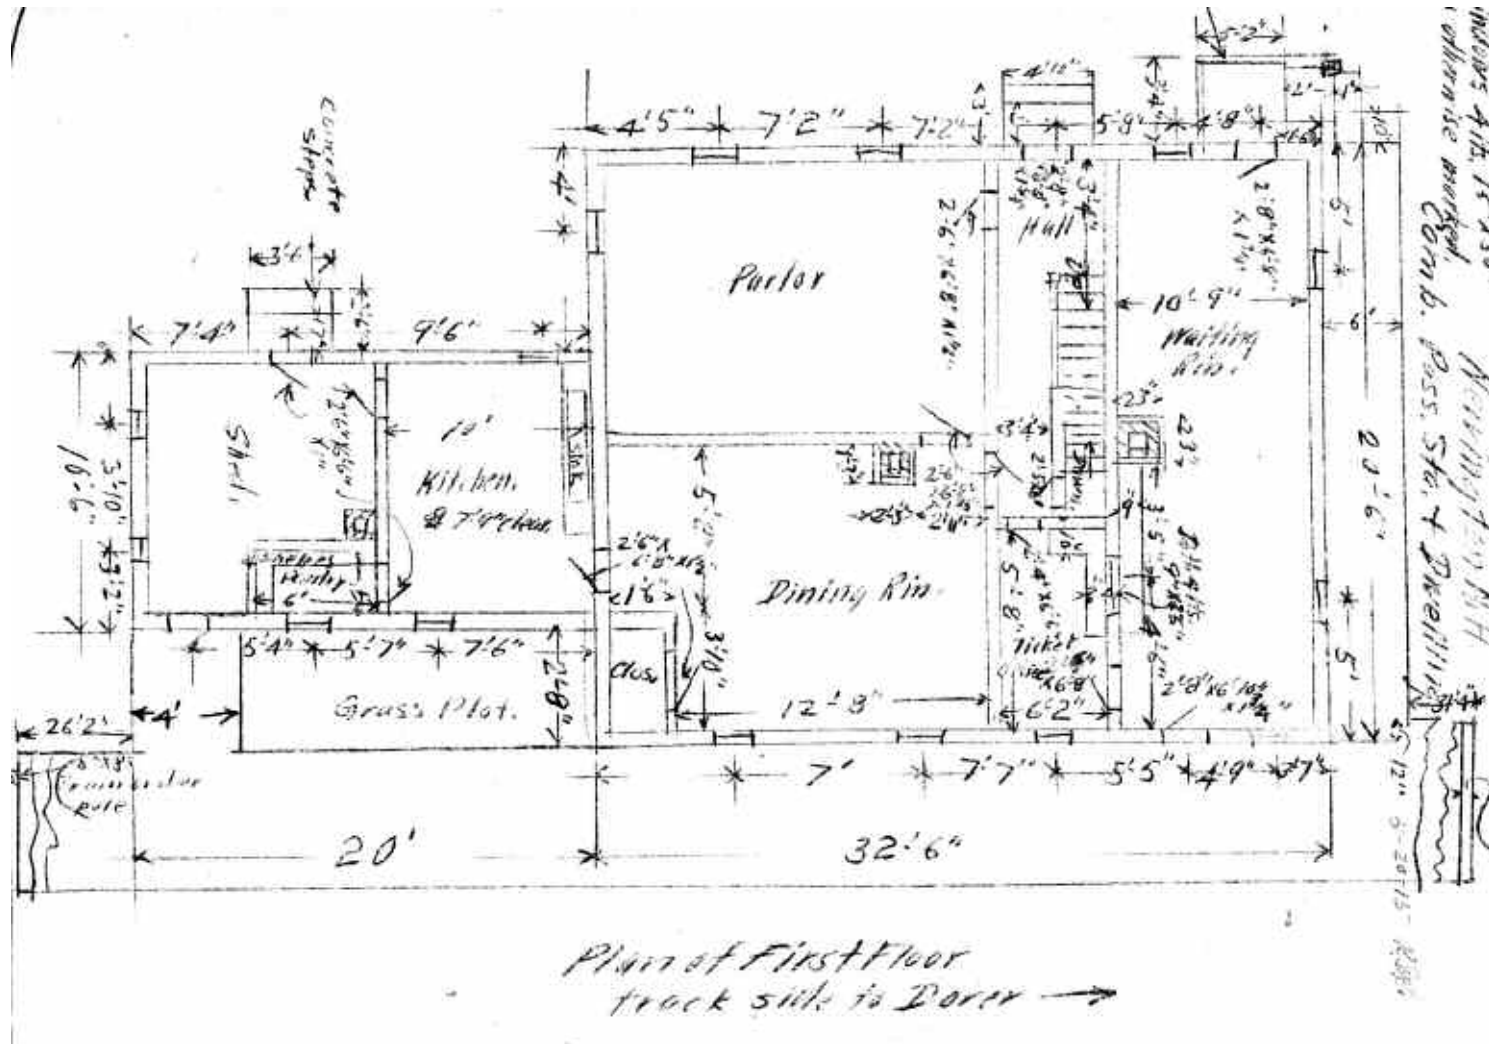
Internal floor plan

The building has a small footprint = 660 square feet plus a 180-square foot shed.

One concept is to rehabilitate the first floor for public access with bathrooms and a kitchen area.

The shed could be public bathrooms with a crawl space underneath for plumbing.

The front door and stairs could be for access to a second floor/attic rental space.

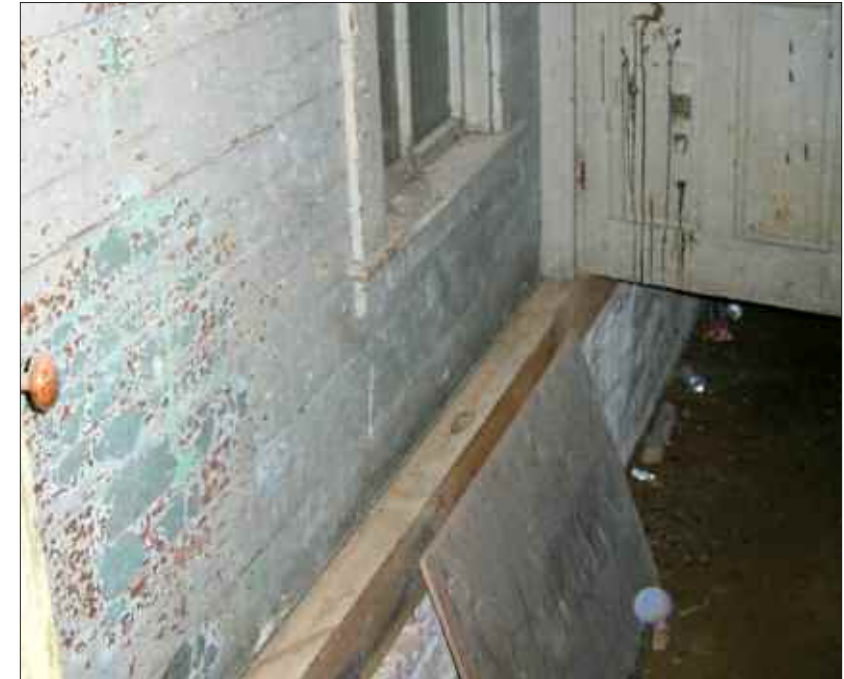
The inside sills and brick foundation in the shed (right) looked new in 2009

A floor needs to be installed in the shed to create a crawl space below for electric, plumbing, etc.

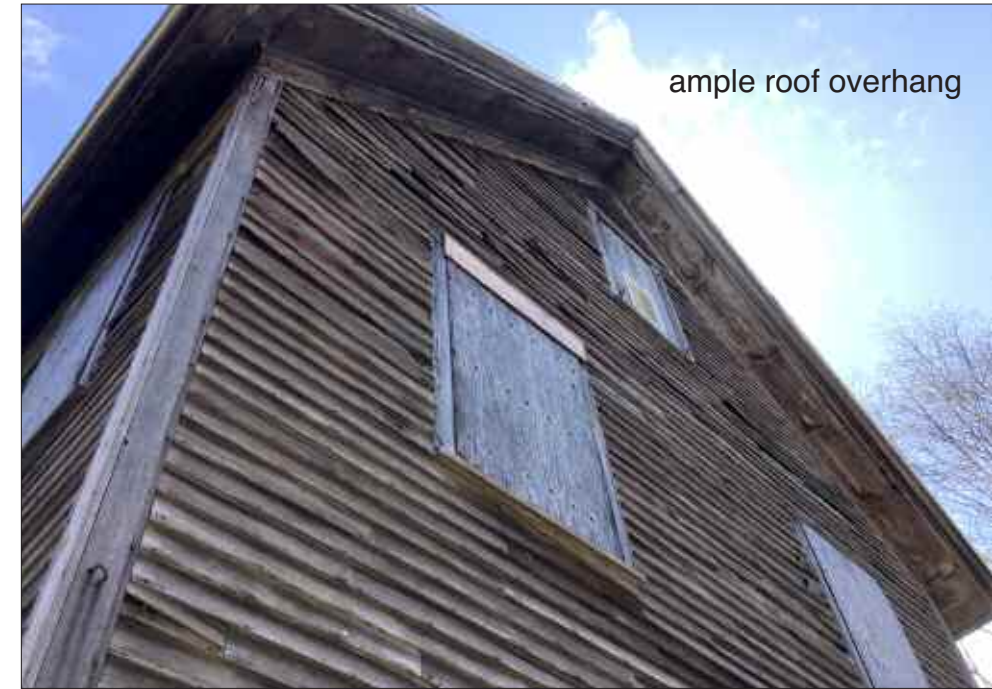
ample roof overhang

The roof overhang gives space for using (or not) outside insulation to preserve the internal plastered walls.

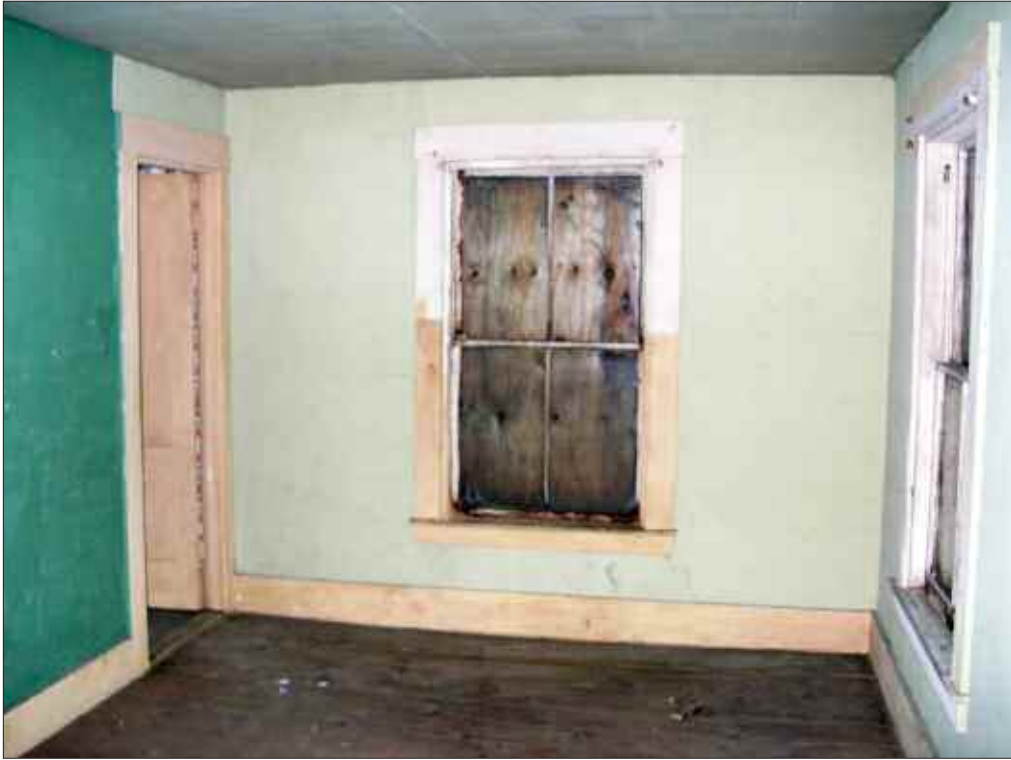
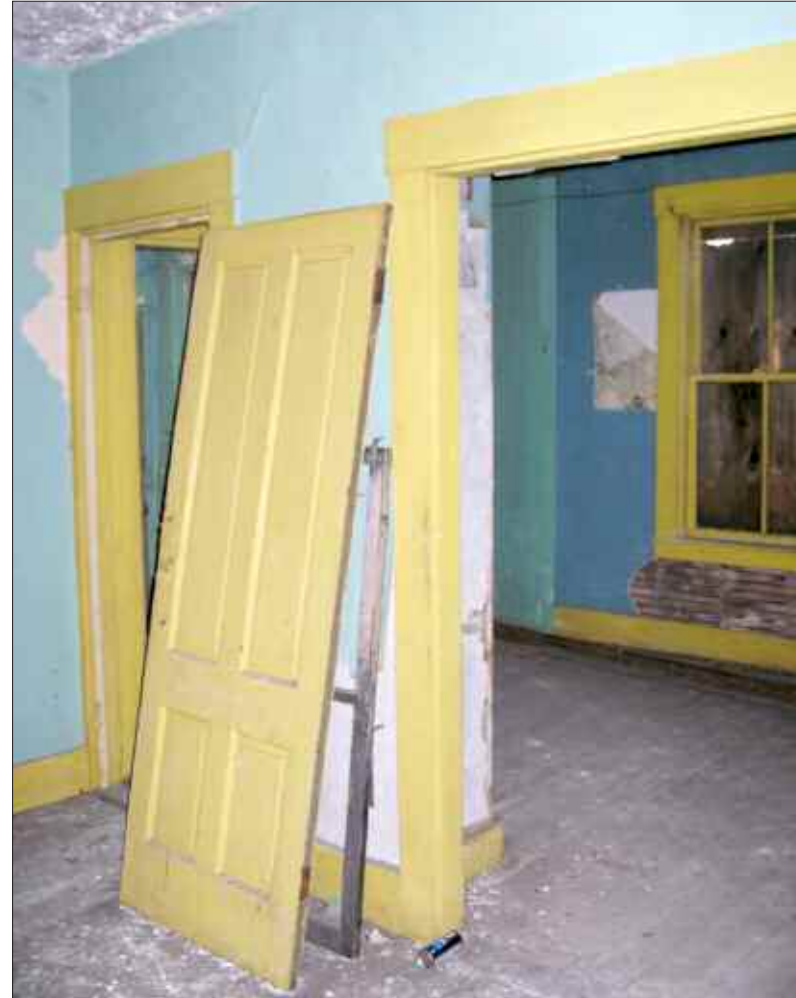
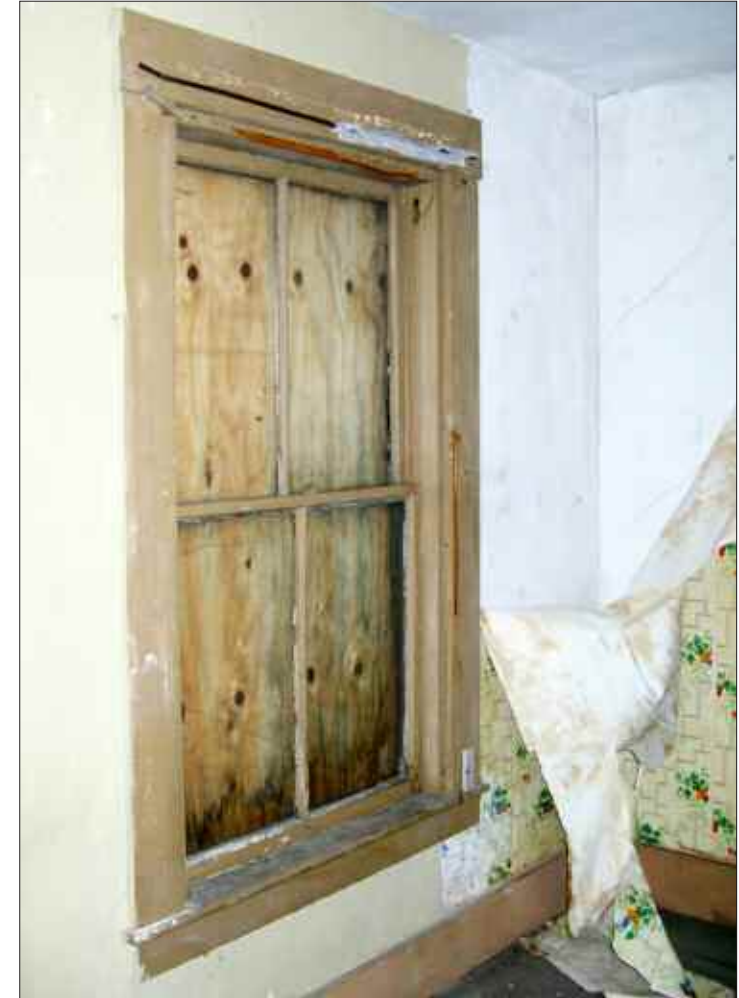
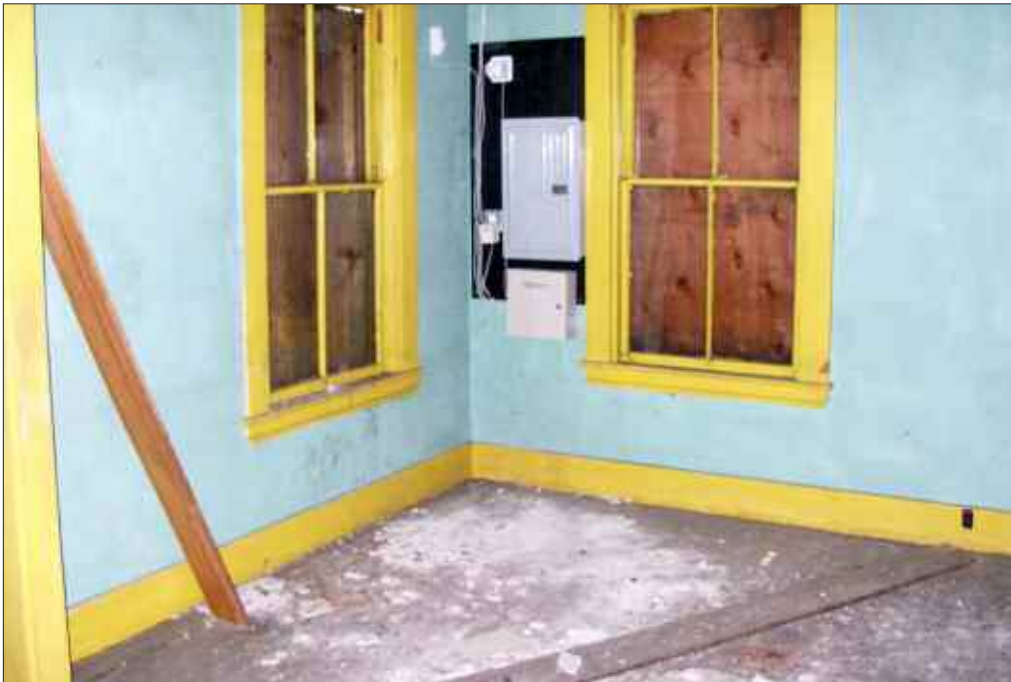
Internal rooms – 2009

It looks like the plaster walls had wallpaper that was painted. Removing the wallpaper shows the plaster underneath to be in good shape in most places.

The trim is not fancy and could be replaced. But it looks to be in good condition and could be reused if any lead paint is properly handled.

Electric panel in photo to the left.

Some ceilings may have had sheetrock installed.

Many floors look like wood floors that could be sanded and refinished.

Everything needs to be checked for lead paint and asbestos.

Chances are that light sanding and encapsulation would work on all the woodwork to address lead paint if present.

All rooms need to be painted.

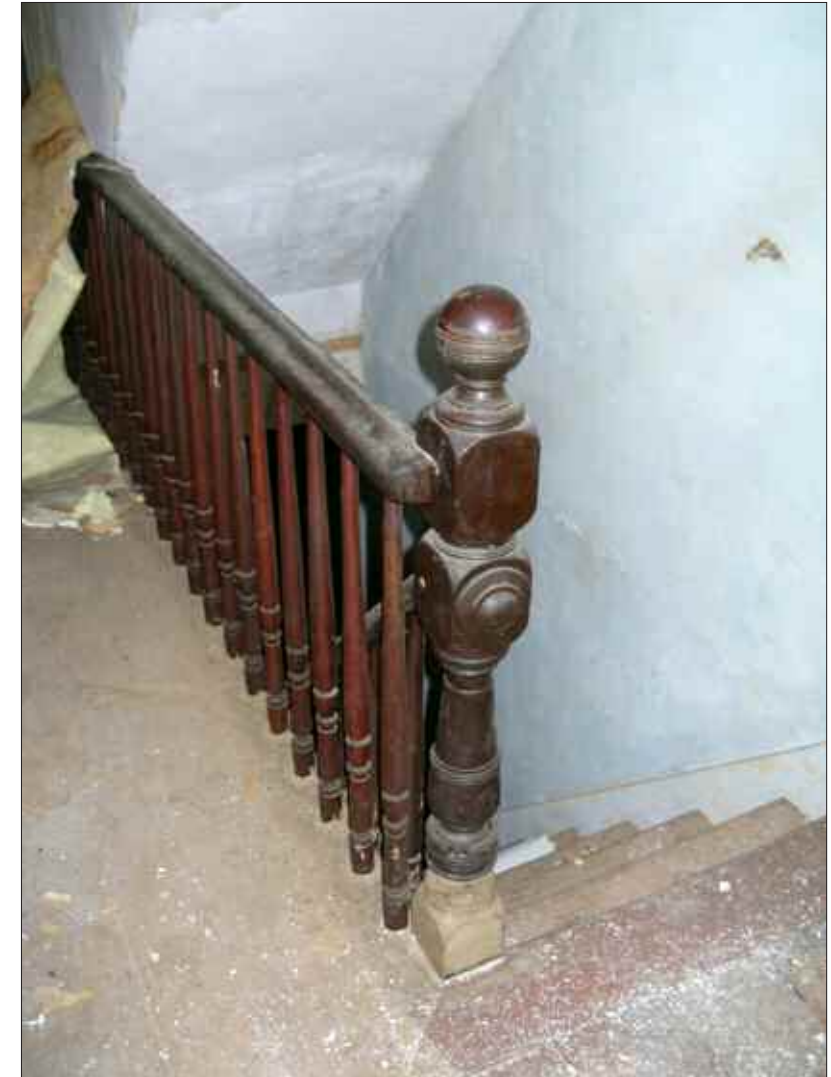
Although not to code, the building is historic and the 3 stairs can likely be refinished and used as is. Note the good state of repair of the plaster walls.

Consider using external insulation to preserve these walls.
